# DRAFT Environmental Assessment

Environmental Restoration
Palm River - Tampa Bypass Canal
Hillsborough County, Florida

### PALM RIVER RESTORATION

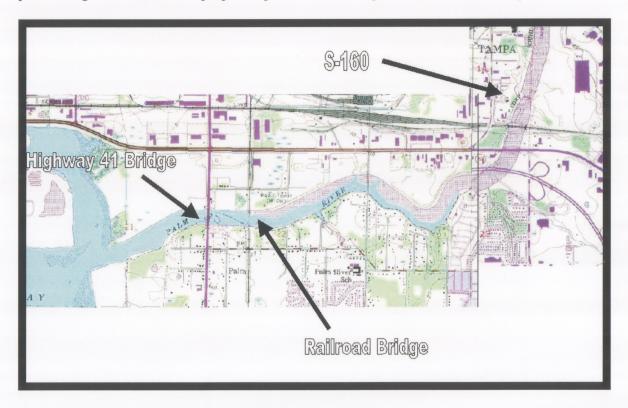
Figure 2, Site Map

The berm beneath the U.S. Highway 41 bridge spans the length and width of the bridge. The elevation of the top of berm is approximately -5 feet NGVD. Removal will include the width of the berm, approximately 100 feet, covering approximately 400 feet or two-thirds of the bridge's length. It will be removed down to -20 feet NGVD with the bridge piers being stabilized with riprap if required. The dredged material would be placed in

the upland Dredged Material Management Area (DMMA)located near the mouth of the Palm River as it enters McKay Bay. If the placement of dredge material occurs during 1 April through 31 August a Migratory Bird Protection Plan would be implemented. Impacts on manatees would mitigated by implementing a manatee protection plan which involves monitoring and avoidance.

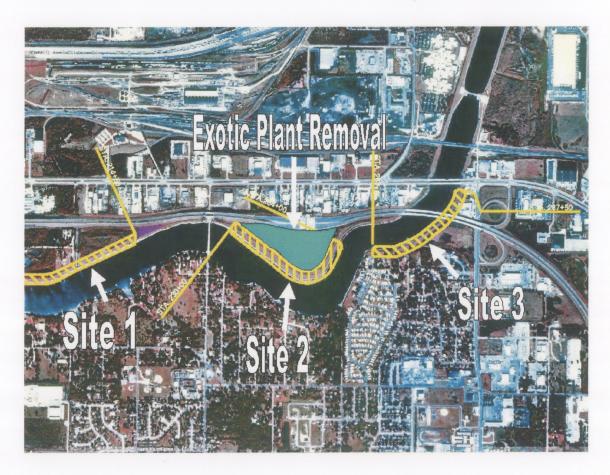
Figure 4, Wetland Restoration Sites

The berm beneath the U.S. Highway 41 bridge spans the length and width of the bridge. The elevation of the top of berm is approximately -5 feet NGVD. Removal will include the width of the berm, approximately 100 feet, covering approximately 400 feet or two-thirds of the bridge's length. It will be removed down to -20 feet NGVD with the bridge piers being stabilized with riprap if required. The potential restoration sites are shown in Figure 4. An area encompassing approximately 1 acre at Site 1 is proposed for restoration to a saltmarsh wetland area. The existing berms will be degraded and form a slope from elevation 0.0 to +2.0. This area will be planted with *Spartina alterniflora* and *Juncus romerianus* to create the saltmarsh. The excess material will be placed in the channel on

a 1 to 4 slope to create a littoral shelf. The dredged material from underneath Highway 41 Bridge would be placed in the upland Dredged Material Management Area located near the mouth of the Palm River as it enters McKay Bay. If the placement of dredge material occurs during 1 April through 31 August a Migratory Bird Protection Plan would be implemented. Impacts on manatees would be mitigated by implementing a manatee protection plan which involves monitoring and avoidance.

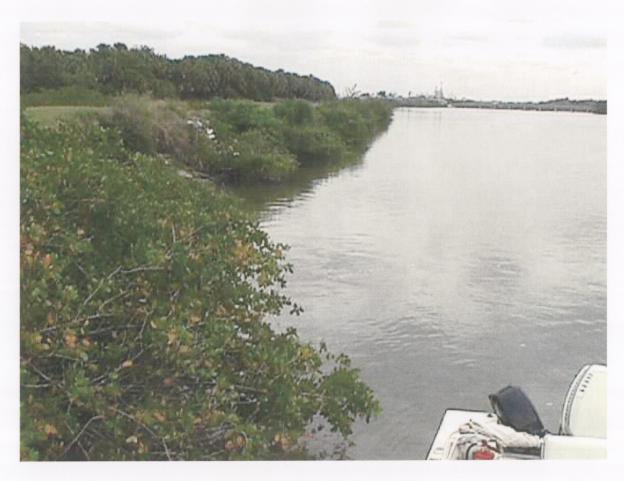
Figure 5, Shoreline Vegetation

- b. Benthic Habitat. Aquatic resources in the Palm River are limited by a lack of habitat complexity and by sub-optimal water quality. The river channel is deeply incised with a very narrow (1-2 feet wide) littoral shelf in the areas where a shelf exists. By and large the river's side slopes are steep, descending from the elevated berm to the bottom with no slope change, giving the river a manicured appearance. Shoreline vegetation is sparse and is present above the high water line, offering minimal cover. The river's bottom has a slowly undulating depth of 17 to 20 feet from structure S-160 to its mouth, with prominent ridges beneath bridge crossings (HDR Engineering 1994). At stations located near the river's mouth and at the Highway 41 bridge, 97% of the sediments collected were mud and silt and it is likely that the river's substrate is predominantly very-fine grained. These physical attributes, taken in their combination, describe a channel that provides limited aquatic habitat.

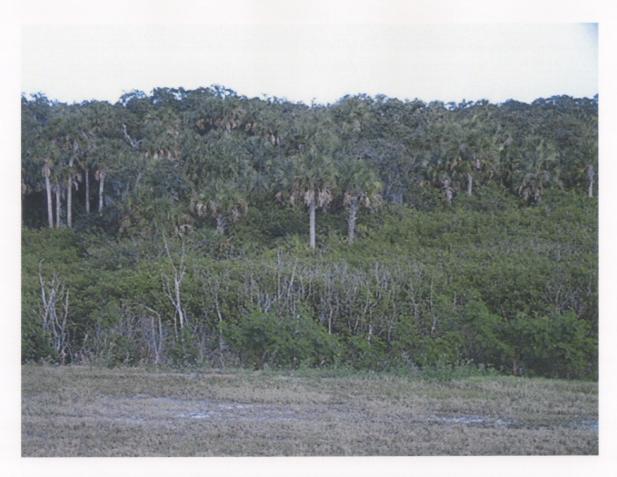
Figure 6, Cabbage Palm Hammocks.

b. Wetlands. From its mouth at McKay Bay to the Highway 41 bridge both shorelines are at natural elevations and shoreline vegetation is dominated by mangroves (Avicennia germinans and Rhizophora mangle). To the south is 160 acres of land owned by the Southwest Florida Water Management District on which three spoil disposal sites are located. The infrequently used disposal sites cover 85 acres. Their interiors contain large areas of shallow water and mud flats where the plant community composition is determined by flooding that occurs during rainy periods and by periodic dredged material disposal. Coastal hammock covers most of the remaining 75 acres, with a fringe of mangroves along the river and mosquito ditches dredged into the property. Cabbage palm (Sabal palmetto), live oak (Quercus virginiana) and American elm (Ulmus americana) are the dominant native vegetation in the hammocks, with Brazilian pepper (Schinus terebinthifolius) and woman's tongue tree (Albizia lebbeck) common exotic species. To the north is 70 acres of fish and wildlife habitat; about 30 acres of intertidal habitat and 40 acres of coastal hammock. The intertidal habitats are dominated by mangroves with black needlerush (Juncus roemerianus) marsh and saltern habitat also present. Cabbage palm and live oak are the common coastal hammock species.

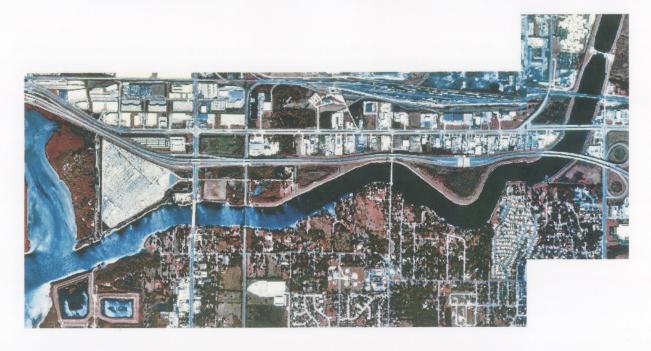
Figure 7, Area Aerial Photograph

**b.** Aesthetics. The existing setting of the Palm River at this location is a mixture of residential, industrial and undeveloped lands. Commercial property exists on the north bank near the mouth, while the south bank is the site of several upland disposal areas. The Dredged Material Management Area is used by waterfowl, as the dredged material placement within these bermed areas is infrequent. The property along both banks is relatively undeveloped. The south bank contains many properties having boat docks. A densely populated area near the upper end of the project is composed of mobile homes. The undeveloped areas along the banks were used for dredged material placement. One of the sites along the north bank is a former landfill. The north bank of the canal has a berm running adjacent to the bank.
